**RAPPORTO ESAMI
ULTRASUONI**

ULTRASONIC EXAMINATION REPORT

UT nr. 120/22 pag. 001 di 006
sheet of

LEOPARD 45 -

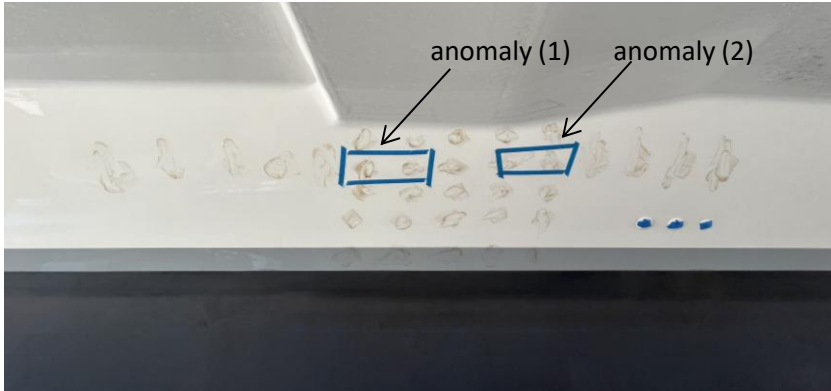
Picture 3 - US map #20 PS

#20 PS:

From outer US inspection, two major significant anomalies have been detected inside the thickness of the single skin outer hull laminate near the bridge connection (depth of the interlaminar discontinuities 2 mm, dimensions 250x100 and 300x100 mm); see picture 3 and US matrix at page 5.

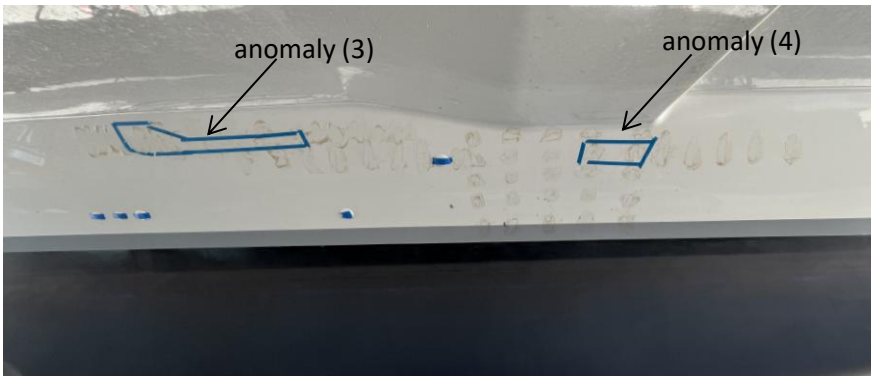
Picture 4 - US map #20 SBD

#20 SBD:

From outer US inspection, two major significant anomalies have been detected inside the thickness of the single skin outer hull laminate near the bridge connection (depth of the interlaminar discontinuities 2-3 mm, dimensions 250x100 and 800x(40/150) mm); see picture 4 and US matrix at page 5.

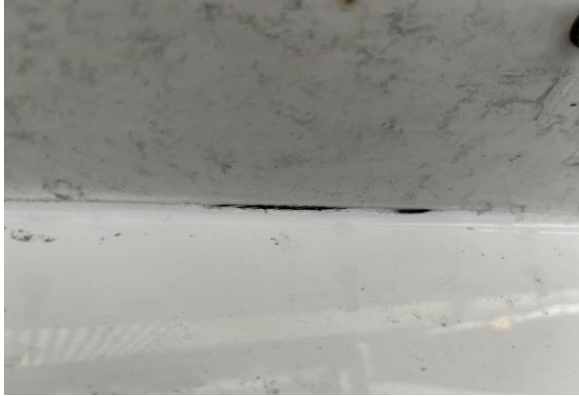
Picture 5 - detail #19

#19:

From outer US inspection, no significant delamination or air inclusions have been detected; the visible indication is due to a surface mechanical damage probably caused during the final polishing of the hull; see picture 5.

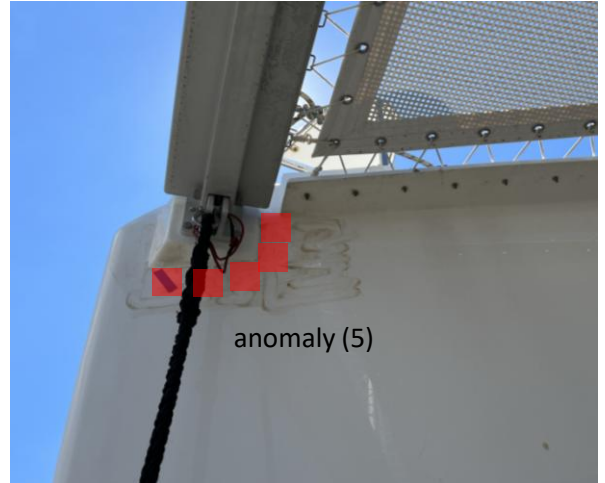
Picture 6 - US map #30 SBD

#30 SBD:

From outer US inspection, various spreaded interlaminar discontinuities at deep 2-3 mm have been detected inside the thickness of the single skin outer laminate around the transverse beam support box; see picture 6 and US matrix at page 6.

A single skin hull total thickness of 7-8 mm have been measured near the transverse beam support box.

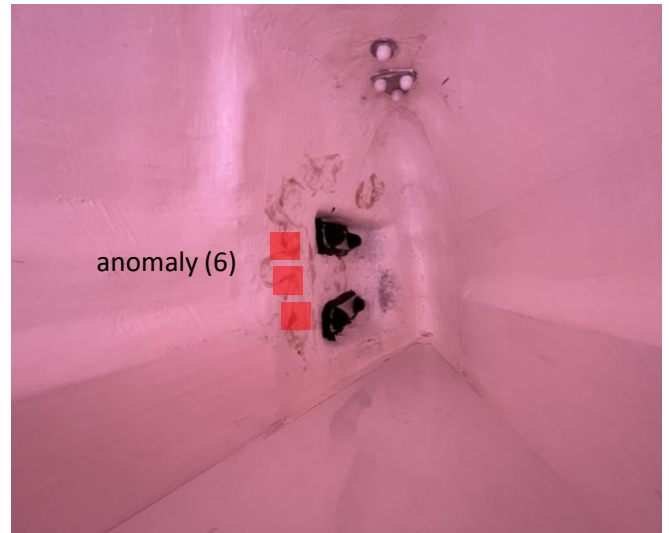
Picture 8 - US map #30 SBD

From inner US spot inspection, some delaminations at deep 2-3 mm have been detected near the singleskin-sandwich transition aft the beam support box; see picture 8 and US matrix at page 6.

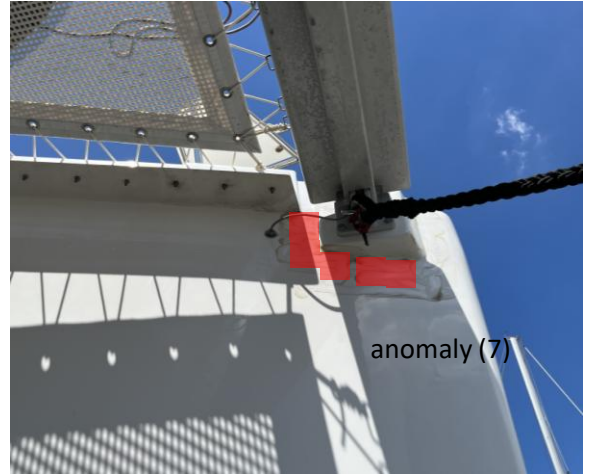
Picture 10 - US map #31 PS

#31 PS:

From outer US inspection, various spreaded interlaminar discontinuities at deep 2-3 mm have been detected inside the thickness of the single skin outer laminate around the transverse beam support box; see picture 10 and US matrix at page 6.

A single skin hull total thickness of 7-8 mm have been measured near the transverse beam support box.

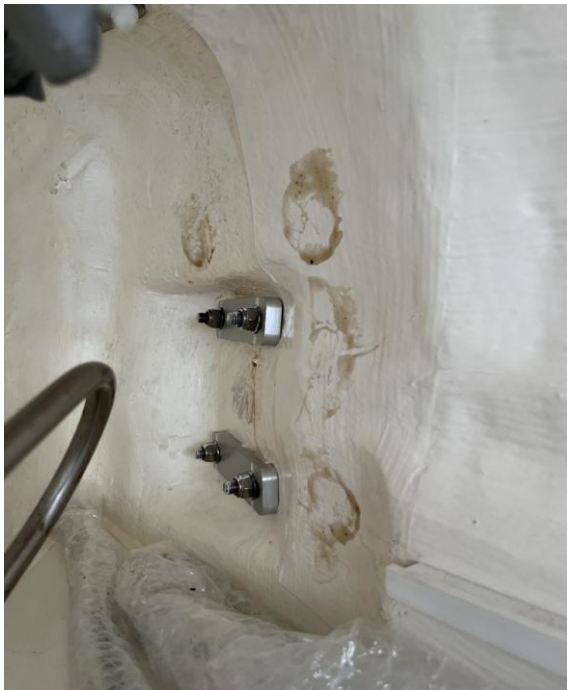
Picture 11 - US map #31 PS

From inner US spot inspection, no delaminations have been detected; see picture 11 and US matrix at page 6.

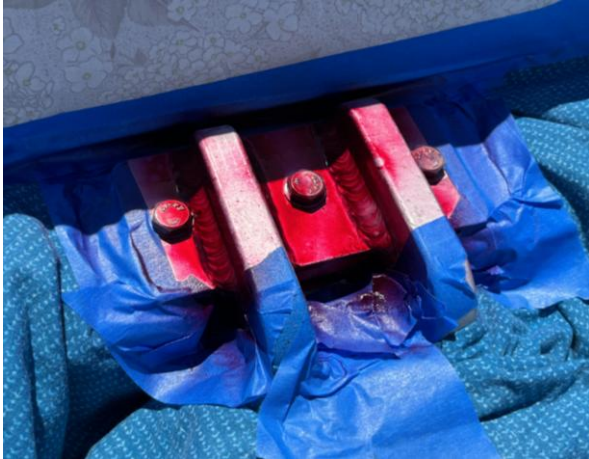
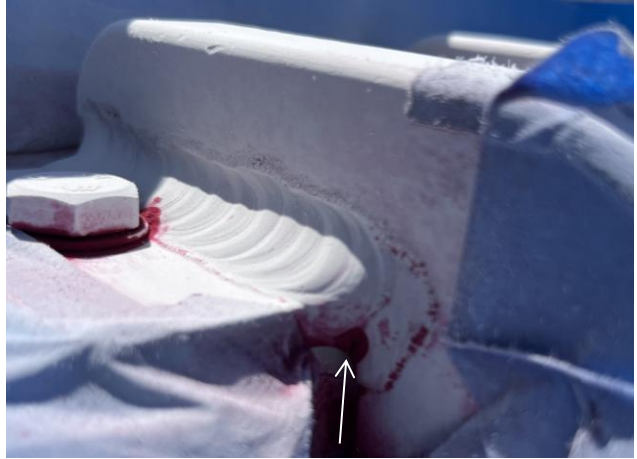
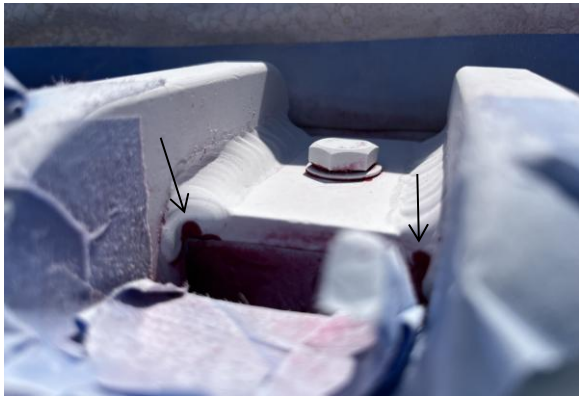
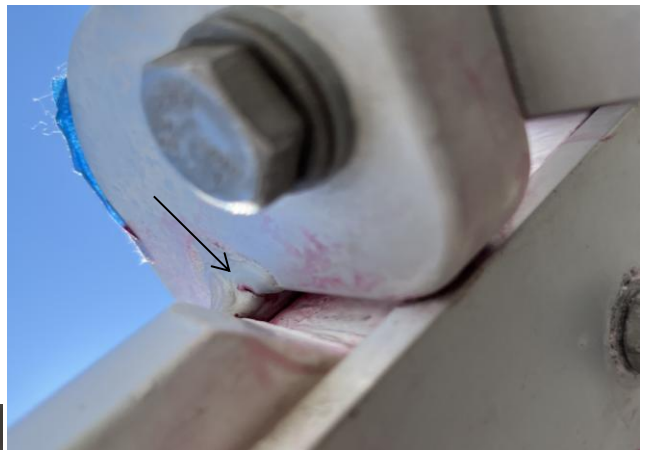
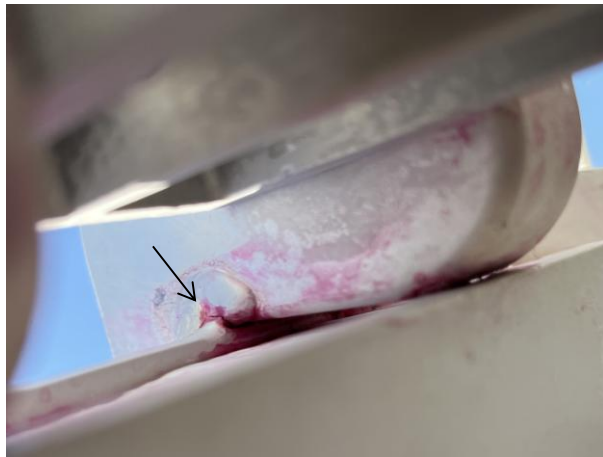
#28:
nr. 3 (three) indications of cracks 3-4mm length at the weld seams end, have been detected.
The welding ends has not been closed correctly.
Not acceptable as per specification.
