# Liger Report - 9 Jun 2022

9 Jun 2022

55 tas ksin this report.

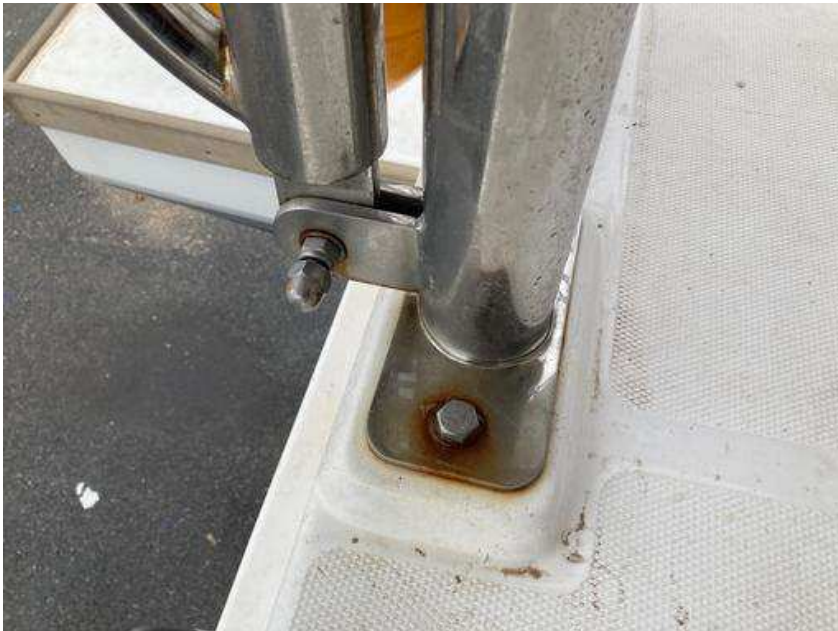
IMG\_0038

The Stainless Steel used on board has been noted with evident oxidation caused by poor material and poor sealing around bases

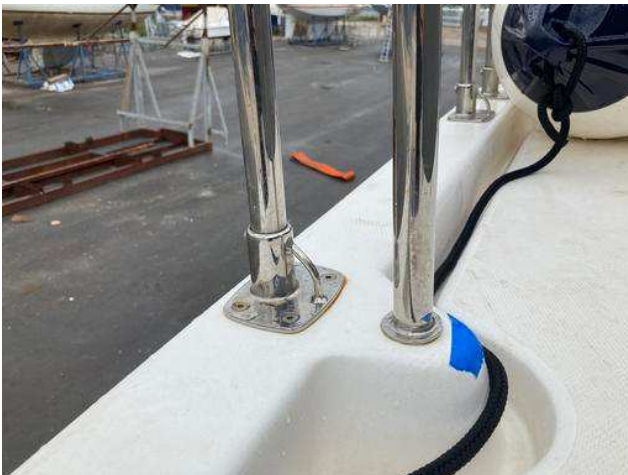
IMG\_0040

The Stainless Steel used on board has been noted with evident oxidation caused by poor material and poor sealing around bases

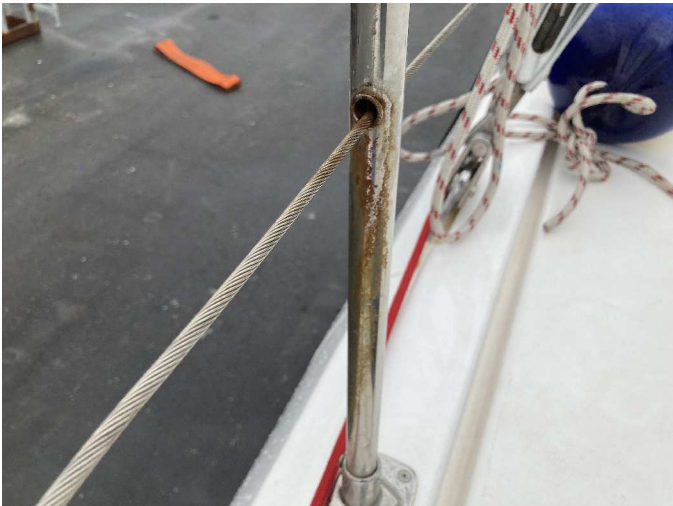
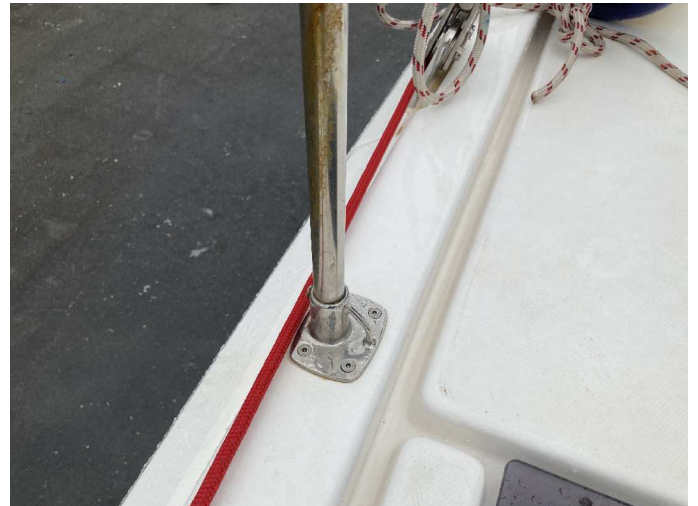
The Stainless Steel used on board has been noted with evident oxidation caused by poor material

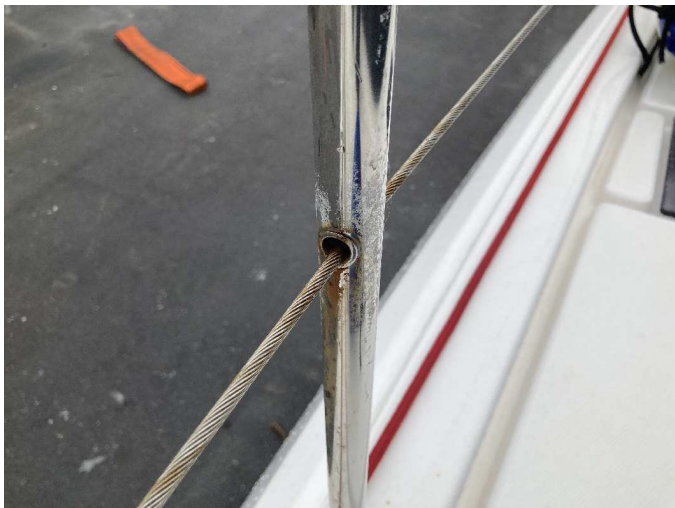
The Stainless Steel used on board has been noted with evident oxidation caused by poor material

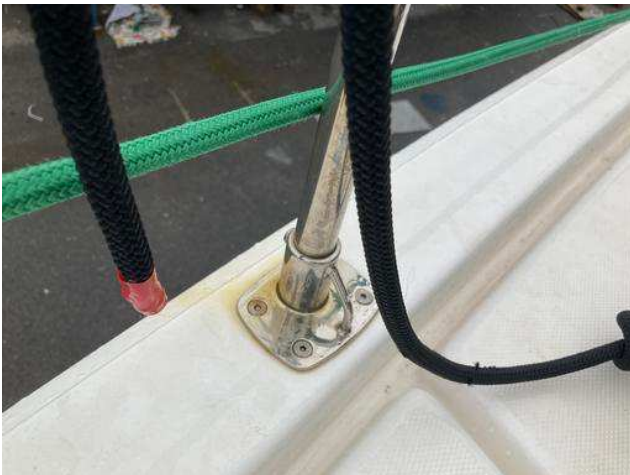
IMG\_0048

The Stainless Steel used on board has been noted with evident oxidation caused by poor material and poor sealing around bases

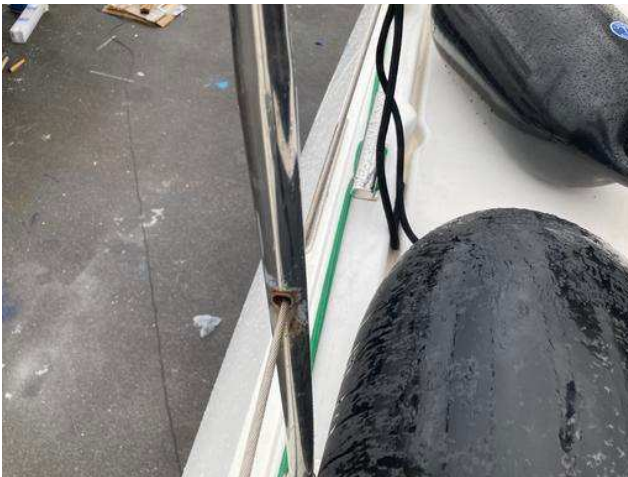
IMG\_0052

The Stainless Steel used on board has been noted with evident oxidation caused by poor material and poor sealing around bases

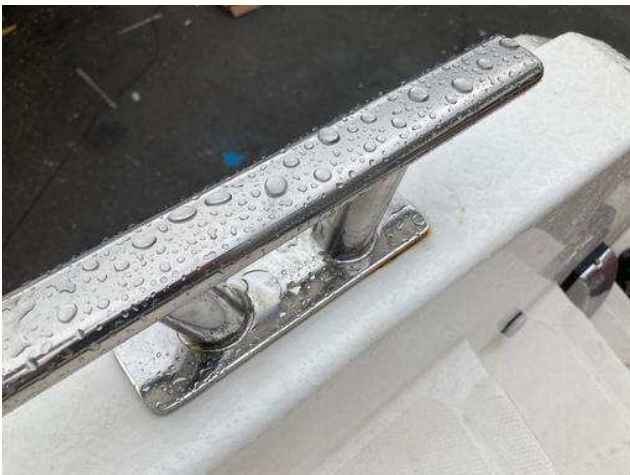
IMG\_0056

The Stainless Steel used on board has been noted with evident oxidation caused by poor material and poor sealing around bases. The port rear cleat is loose and is a safety issue. It actually moves when tied off.

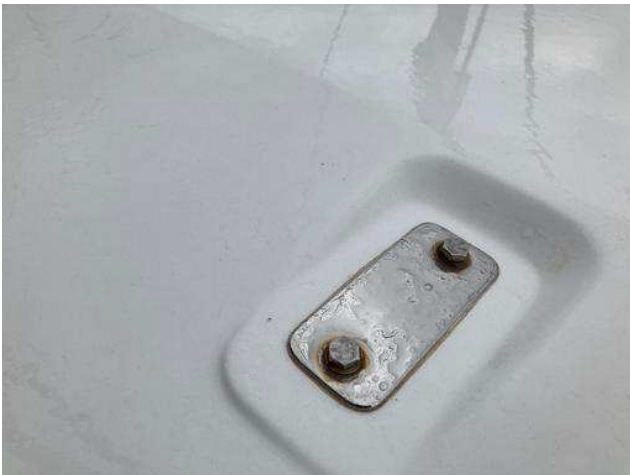
IMG\_0058

The Stainless Steel used on board has been noted with evident oxidation caused by poor material and poor sealing around bases

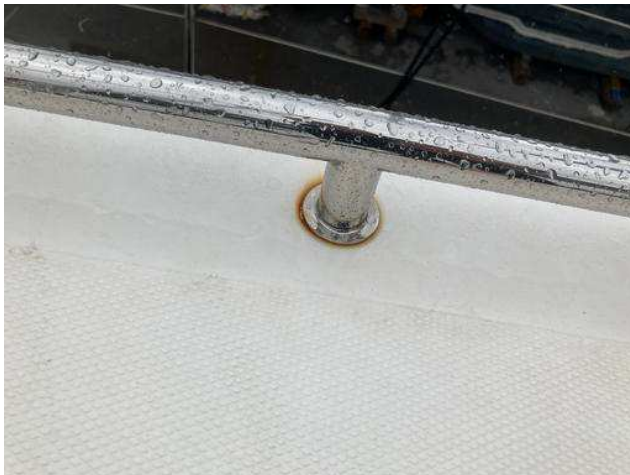
IMG\_0060

The Stainless Steel used on board has been noted with evident oxidation caused by poor material and poor sealing around bases

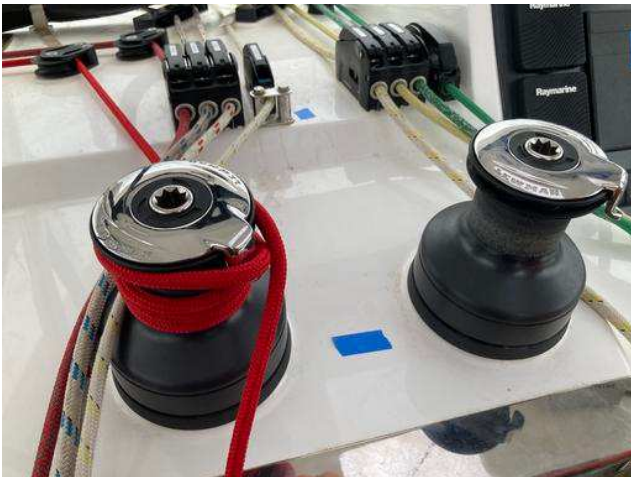
IMG\_0062

**Description**  
The gelcoat reveals several superficial defects on the surfaces

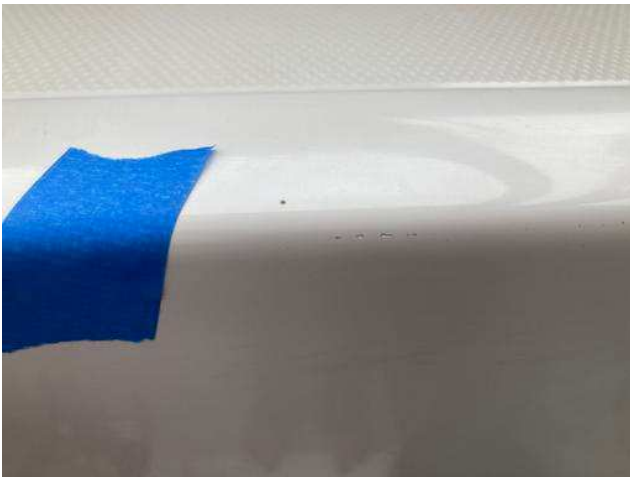
IMG\_0065

The gelcoat reveals several superficial defects (holes ) on the surfaces

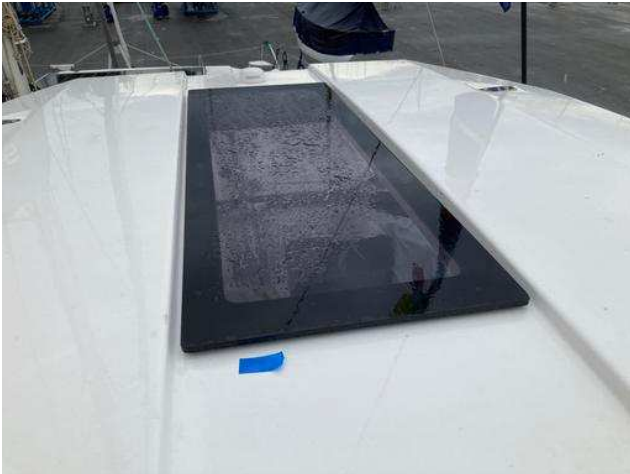
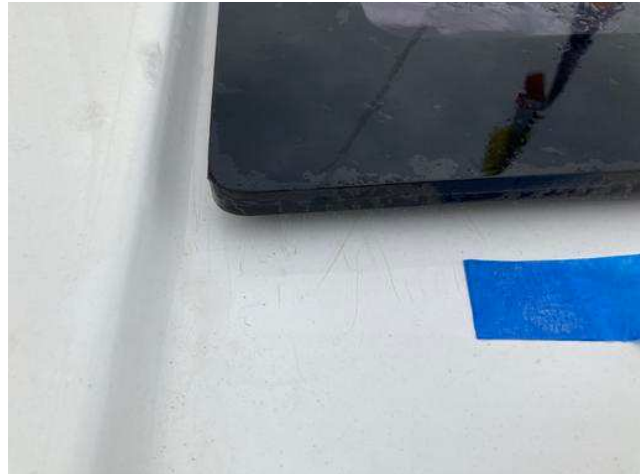
The gelcoat reveals several superficial defects (scratches) on the surfaces around the glasses

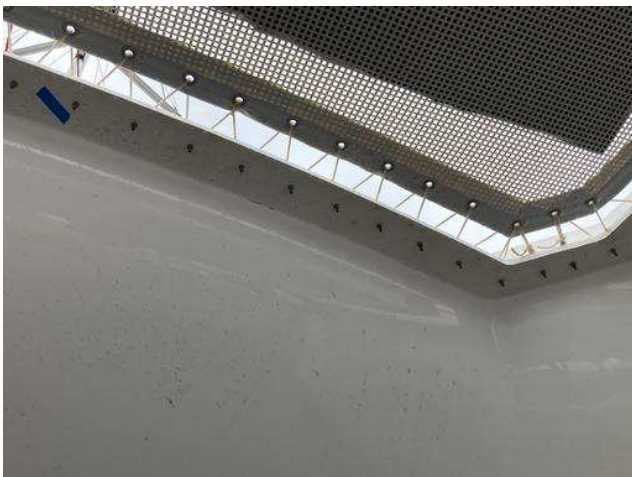
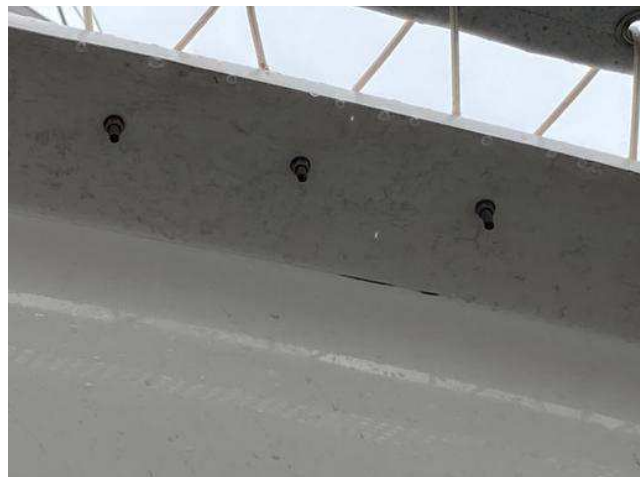
The gelcoat reveals some superficial defects on the surfaces in contact with metal transverse

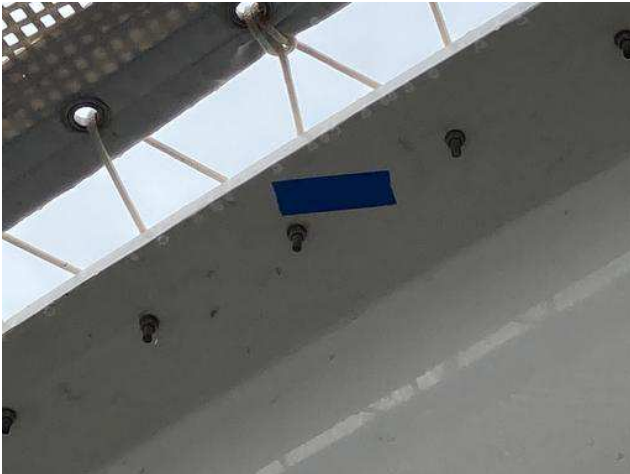
IMG\_0076

The gelcoat reveals some superficial defects on the surfaces in contact with metal transverse

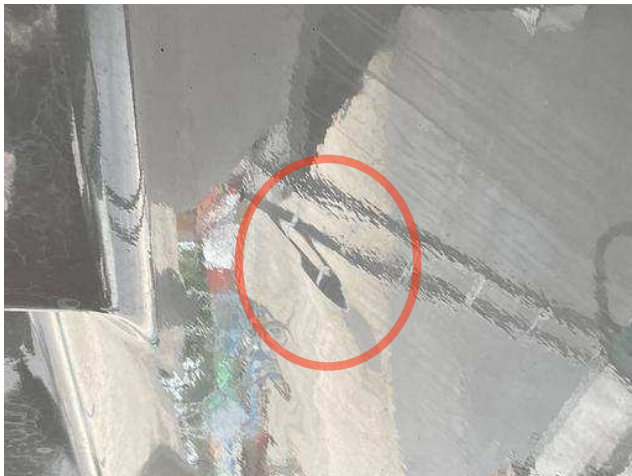
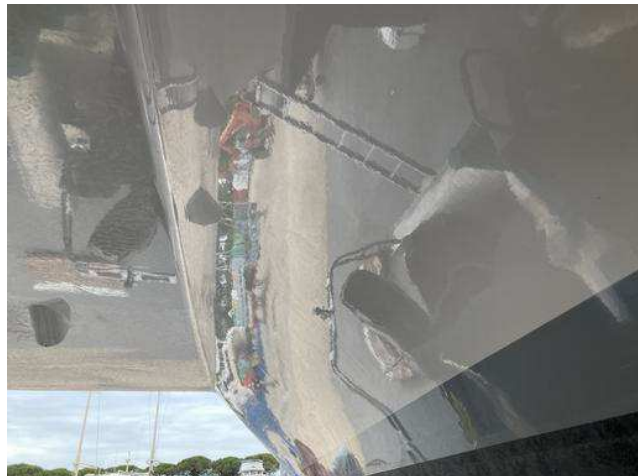
Localised blister appear on gelcoat surface - It has be opened to check the the cause and be repaired

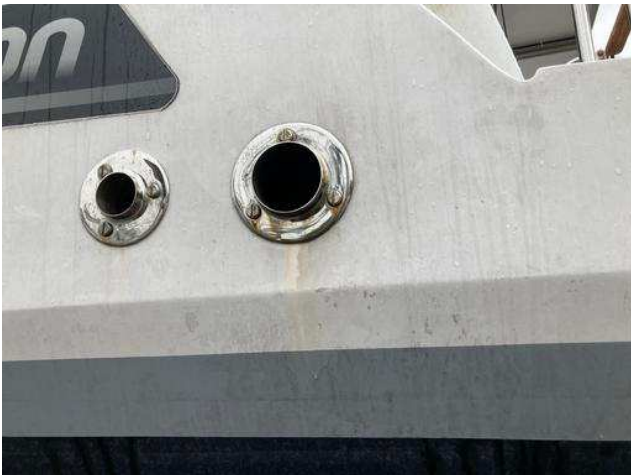
IMG\_0090

The Stainless Steel used on board has an evident oxidation caused by poor material and poor sealing around bases

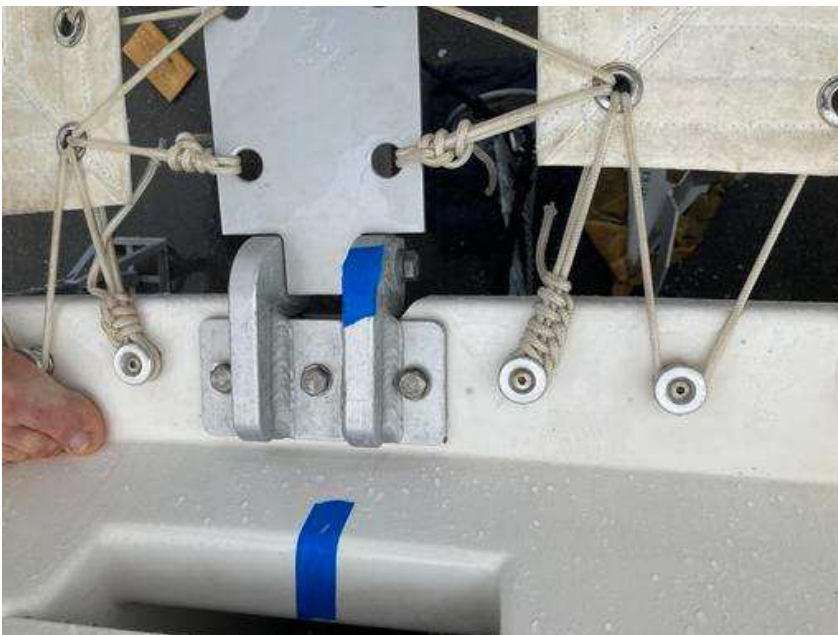
IMG\_0095

Cracks in code zero cross beam support welds . Will need to be removed and replaced for safety reasons

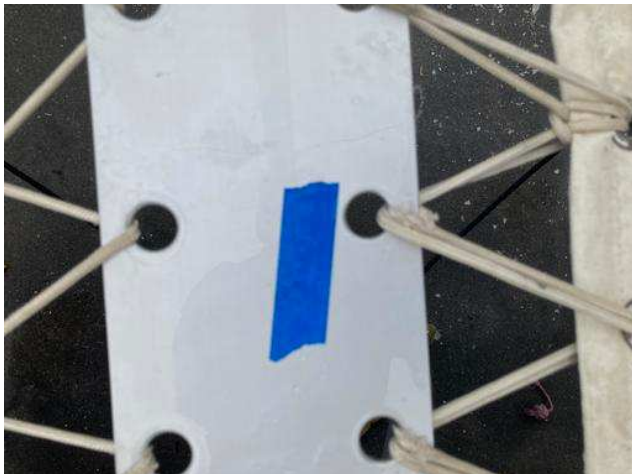
IMG\_0098  
[REDACTED]  
9 Jun 2022 12:48

Not all the holes in the beam are properly finished and the webbing gets cut quickly. It needs to be replaced and the holes appropriately smoothed

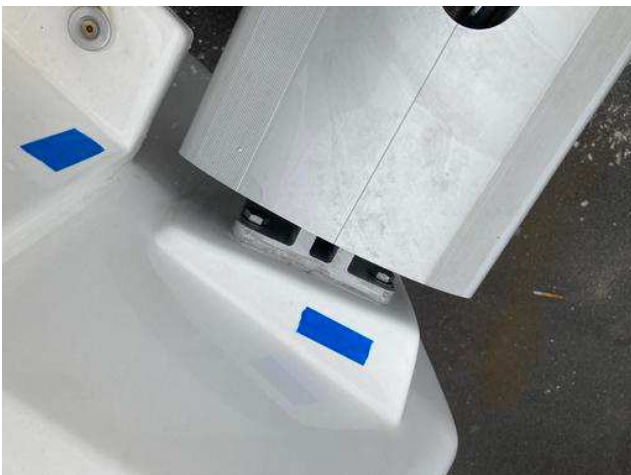
IMG\_0100

Vertical cracks on both sides of the transverse beam support, these have already been repaired once and the cause of their reappearance must be investigated. It could be an extensive repair work with the need to review the lamination plan of these areas and bolts leaking on starboard side

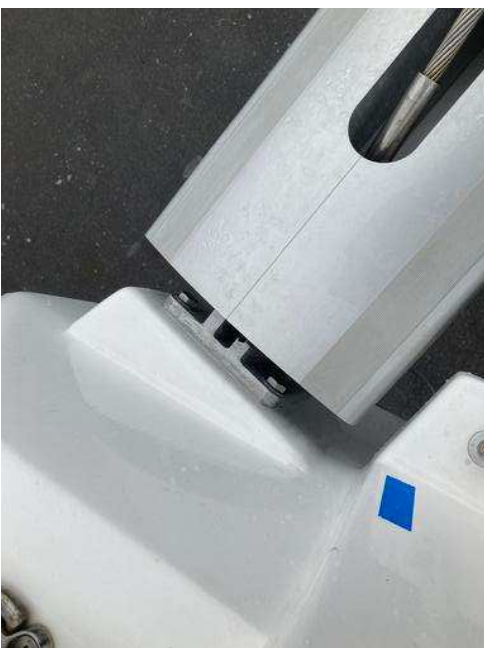
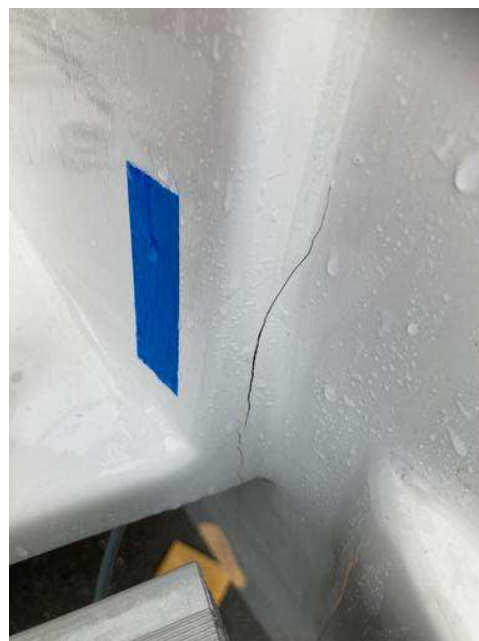
Vertical cracks on both sides of the transverse beam support, these have already been repaired once and require investigation about why they have reappeared. It could be an extensive repair work with the need to review the lamination plan of these areas

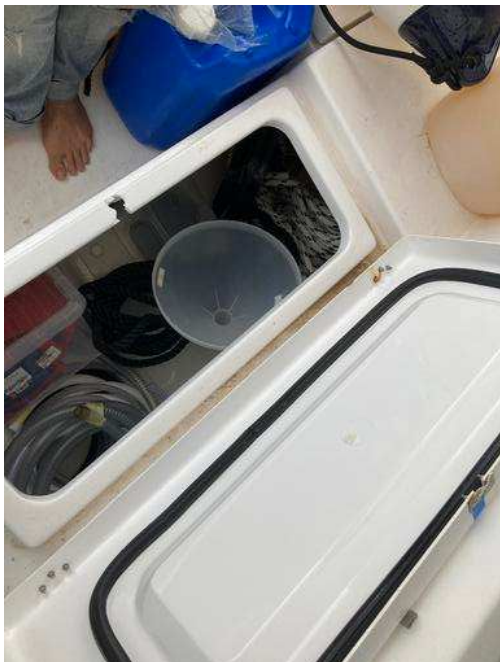
IMG\_0108  
[REDACTED]  
9 Jun 2022 13:00

Hinge system of the technical locker is broken - Gelcoat around the hinge is broken - a review of the lamination structure is needed

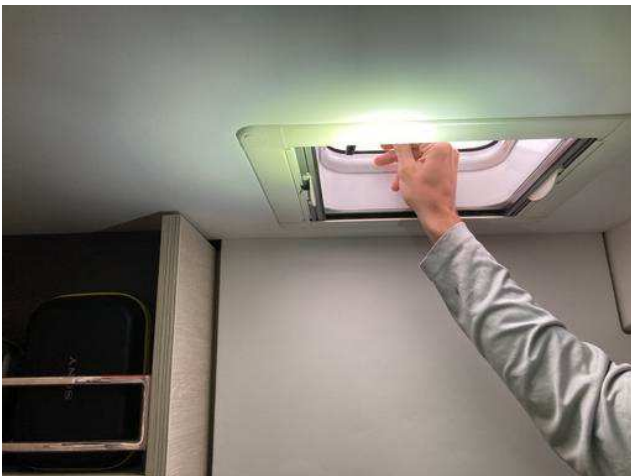
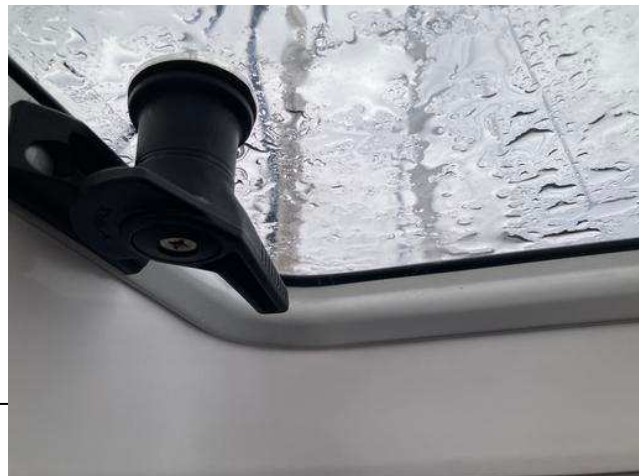
The hatch of the deckhouse on the starboard side shows water leakage, the inadequacy of these aspects affects the integrity of the hull and therefore the safety of the vessel ISO 11812

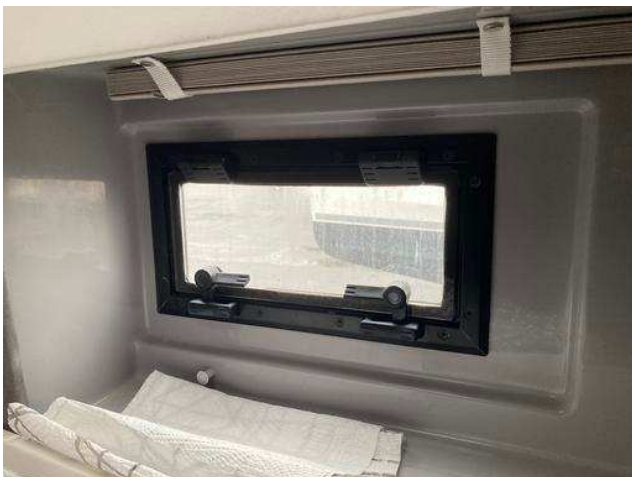
IMG\_0117

The portholes on the starboard side show water infiltration during navigation ; inadequacy of these aspects affects the integrity of the hull and therefore the safety of the vessel ISO 11812

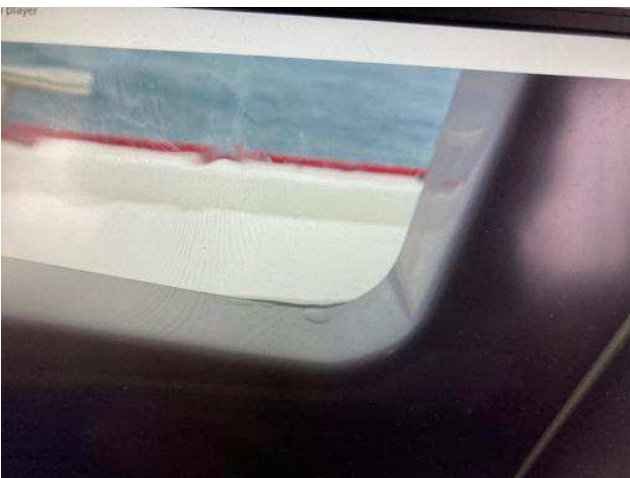
IMG\_0120  
[REDACTED]  
9 Jun 2022 13:07

The glass of the deckhouse windows on the port side shows a high level of water infiltration, the inadequacy of these aspects affects the integrity of the hull and therefore the safety of the vessel ISO 11812

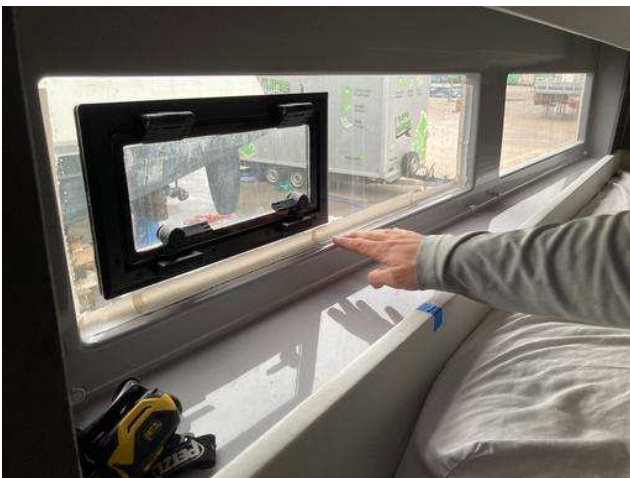
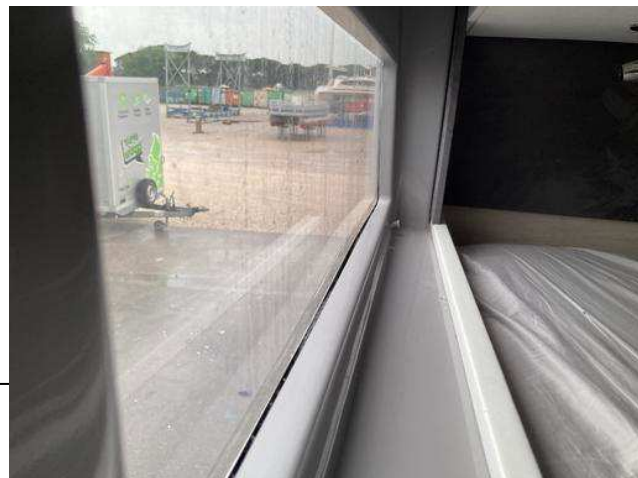
The glass on the starboard side shows high water infiltration during navigation; inadequacy of these aspects affects the integrity of the hull and therefore the safety of the vessel ISO 11812

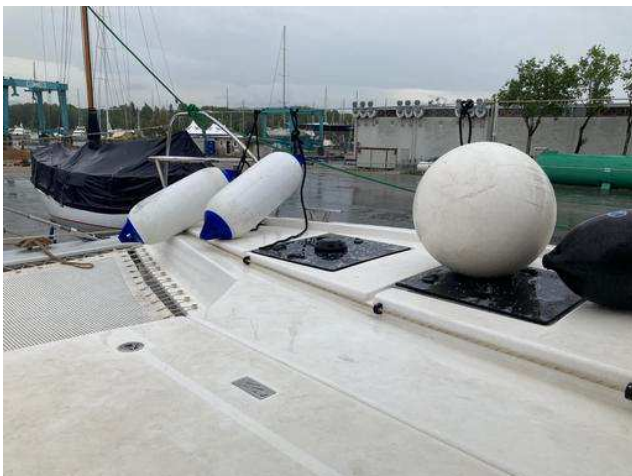
IMG\_0134  
[REDACTED]  
9 Jun 2022 13:20

On the starboard deck forward the manholes show water leakage, the inadequacy of these aspects affects the integrity of the hull and superstructure and thus the safety of the boat ISO 11812.

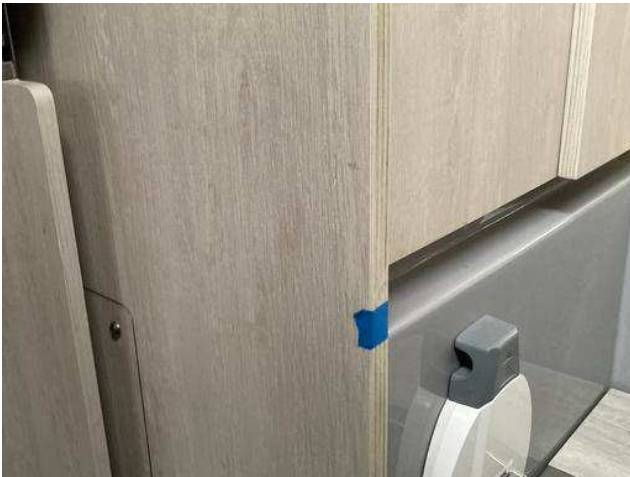
IMG\_0143  
[redacted]  
9 Jun 2022 13:26

**Description**  
The ply wood  
is damaged

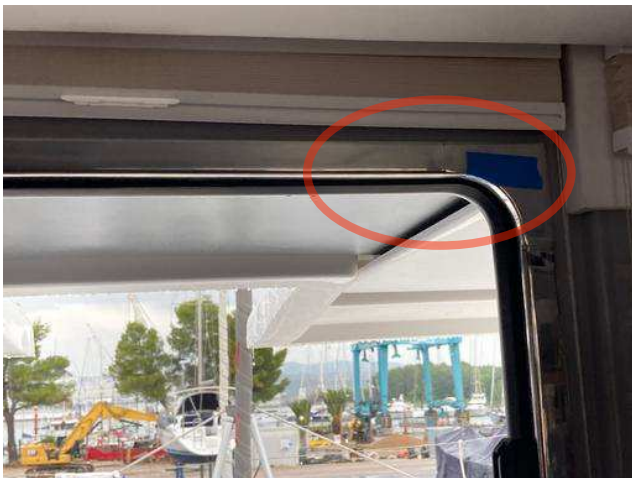
IMG\_0150  
[redacted]  
9 Jun 2022 13:30

The right upper part of the frame shows oxidation formations due to water infiltration from outside. In navigation, the frame moves. The inadequacy of these aspects affects the integrity of the hull and superstructure and thus the safety of the boat ISO 11812

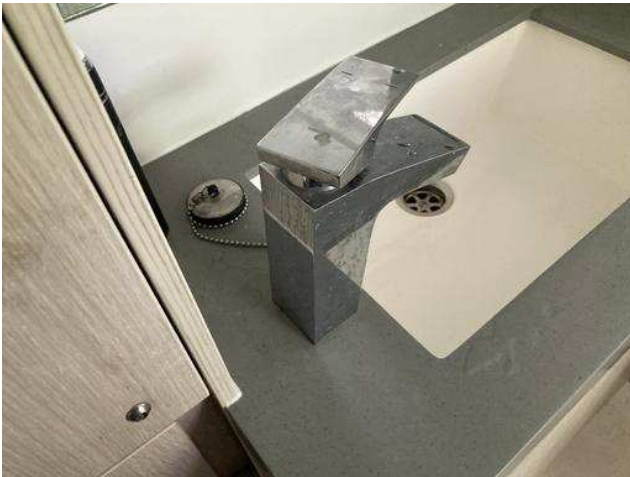
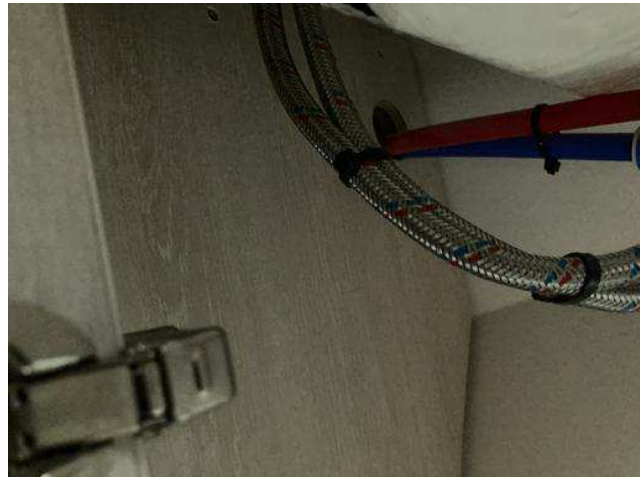
The basin tap shows  
leaks at the base

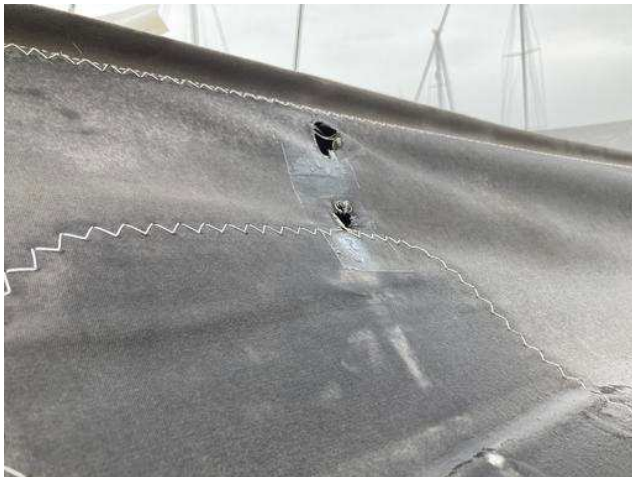
Unknown-1

Mainsail cover is damaged due to incorrect installation of the lady bug
