**RAPPORTO ESAMI
ULTRASUONI**

ULTRASONIC EXAMINATION REPORT

UT nr. 120/22 pag. 001 di 006
sheet of

LEOPARD 45 -

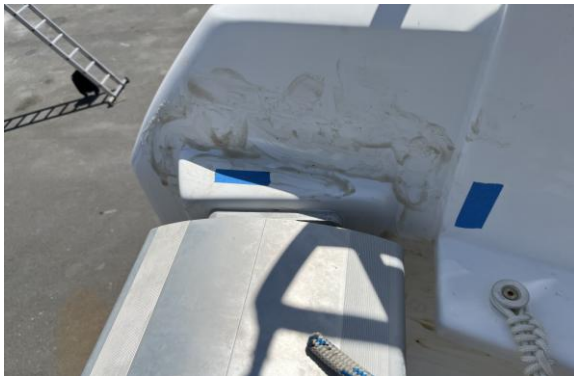
Picture 7 - US map #30 SBD

From outer US inspection, various spreaded interlaminar discontinuities at deep 2-3 mm have been detected inside the thickness of the single skin outer laminate around the transverse beam support box; see picture 6 and US matrix at page 6.
