# Liger Report - 9 Jun 2022

9 Jun 2022

55 tas ksin this report.

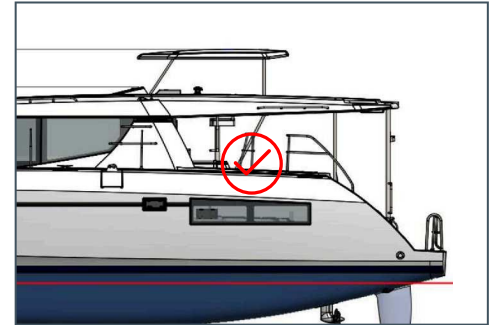
## #02 Inspection date 09.06.2022

The Stainless Steel used on board has been noted with evident oxidation caused by poor material and poor sealing around bases

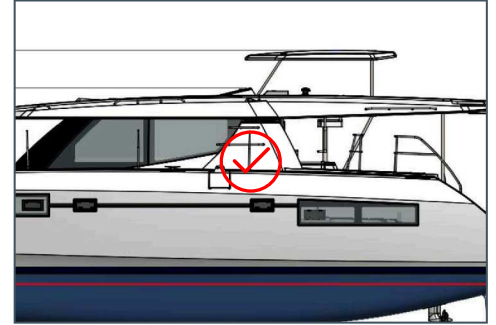
#03 Inspection date 09.06.2022

The Stainless Steel used on board has been noted with evident oxidation caused by poor material

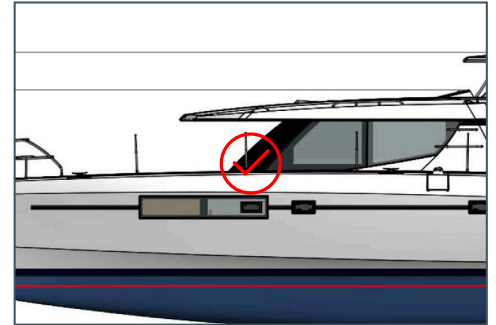
#04 Inspection date 09.06.2022

The Stainless Steel used on board has been noted with evident oxidation caused by poor material

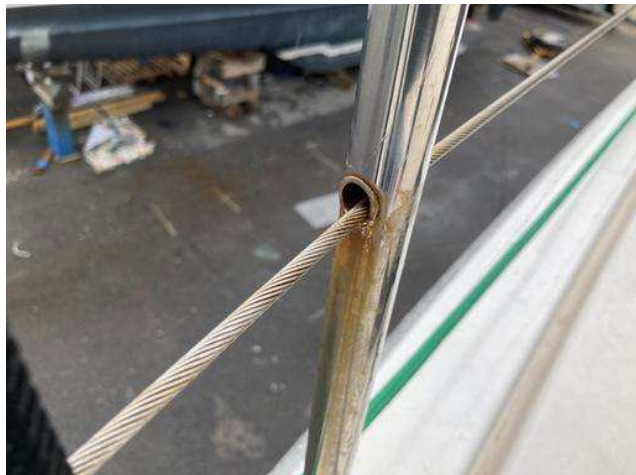
## #05 Inspection date 09.06.2022

The Stainless Steel used on board has been noted with evident oxidation caused by poor material and poor sealing around bases

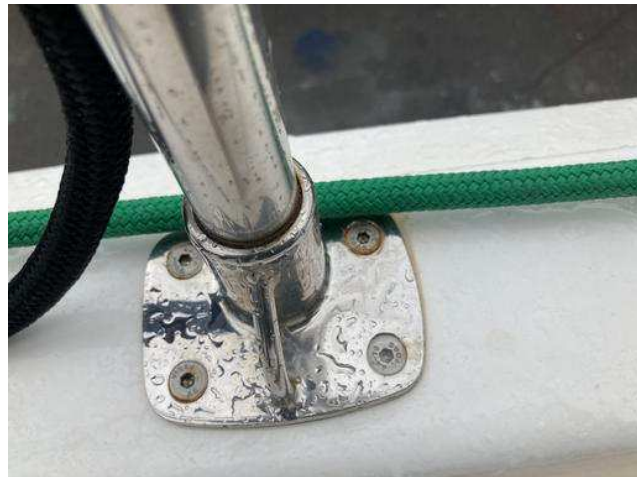
#06 Inspection date 09.06.2022

The Stainless Steel used on board has been noted with evident oxidation caused by poor material and poor sealing around bases

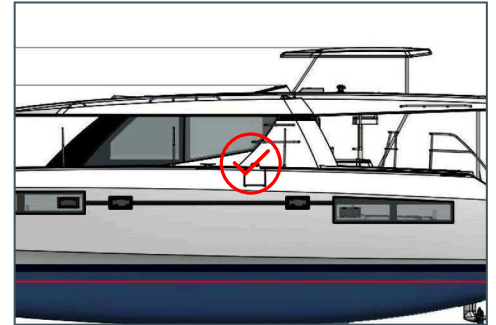
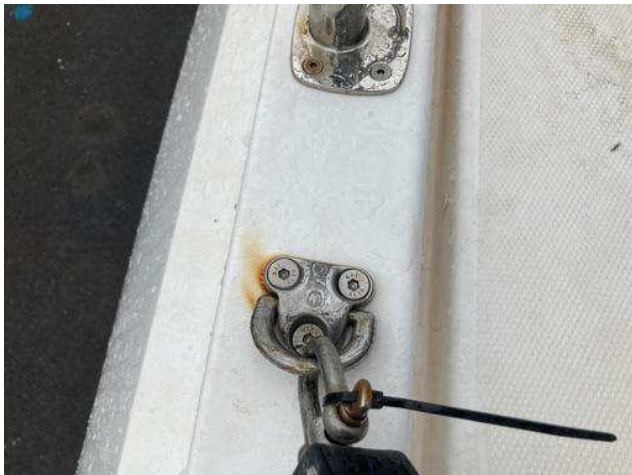
## #07 Inspection date 09.06.2022

The Stainless Steel used on board has been noted with evident oxidation caused by poor material and poor sealing around bases

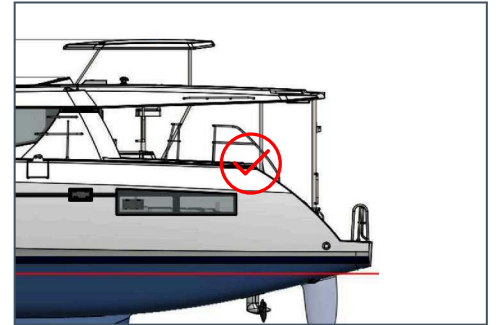
The Stainless Steel used on board has been noted with evident oxidation caused by poor material and poor sealing around bases. The port rear cleat is loose and is a safety issue. It actually moves when tied off.

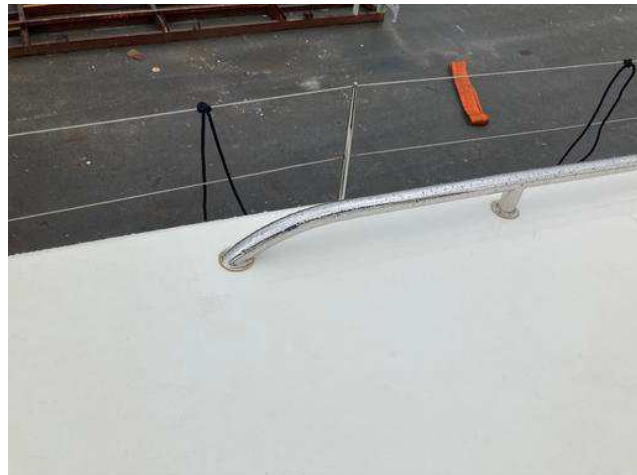
The Stainless Steel used on board has been noted with evident oxidation caused by poor material and poor sealing around bases

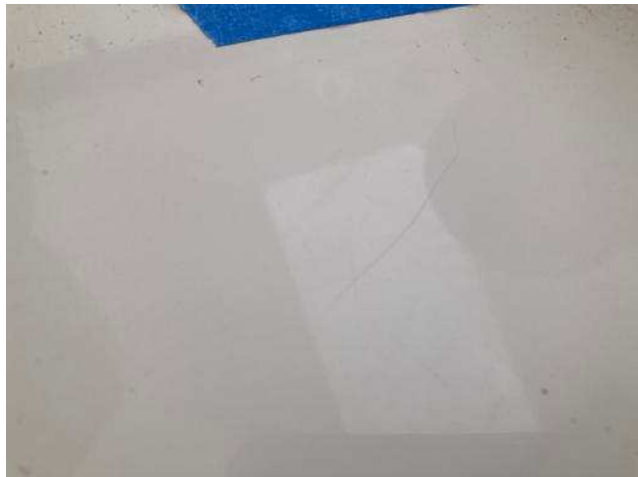
**Description**  
The gelcoat reveals several superficial defects on the surfaces

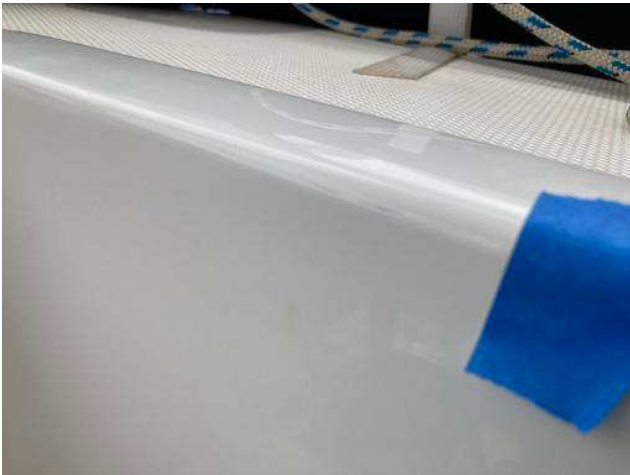
The gelcoat reveals several superficial defects ( low thickness in the corner ) on the surfaces

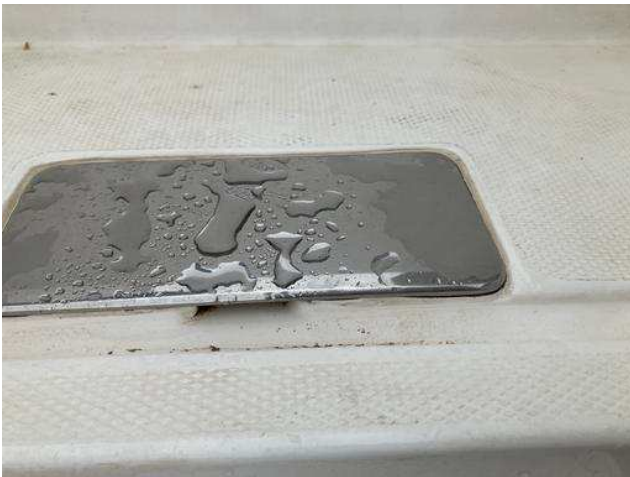
The seal around the  
Stainless Steel plates is  
detached

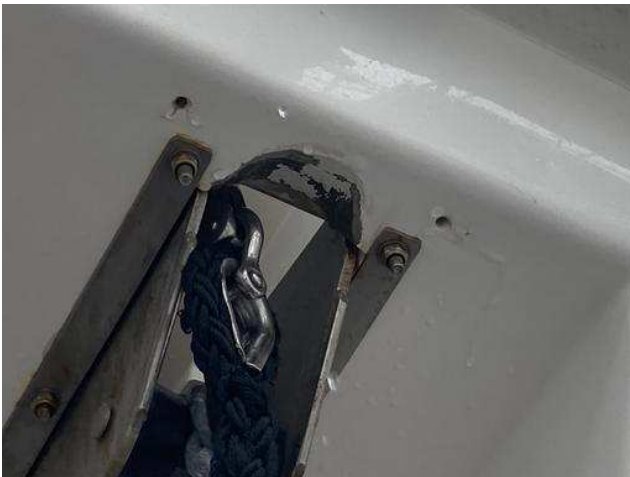
Gelcoat defects around  
the Stainless Steel anchor  
exit

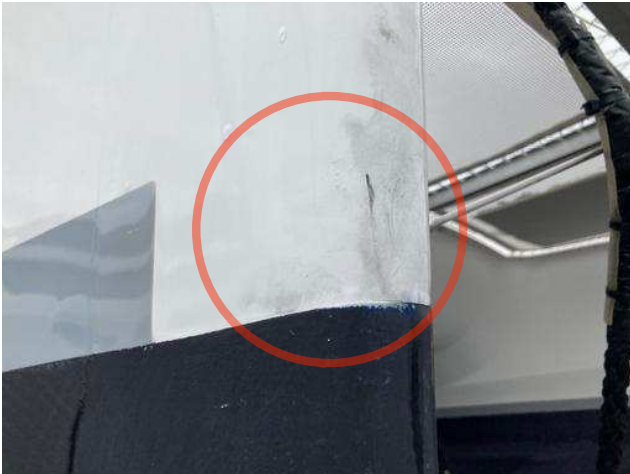
The gelcoat reveals some superficial defects on the surfaces close to the antifouling

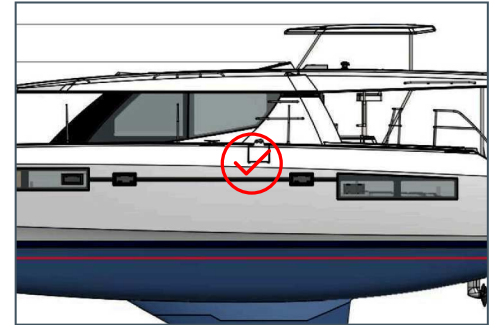
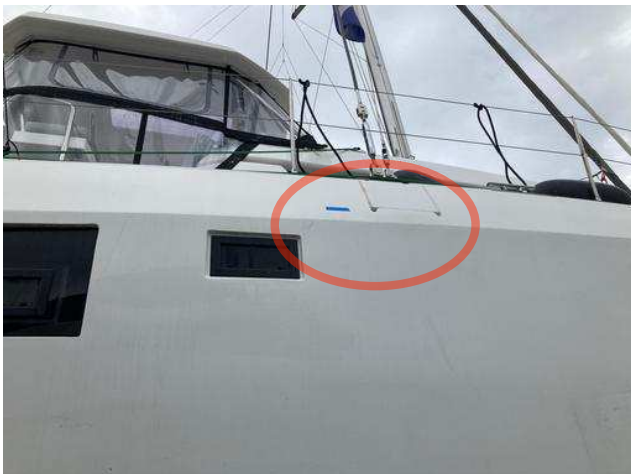
In this area the gelcoat appears flawed -It releases white color when the fender is rubbing

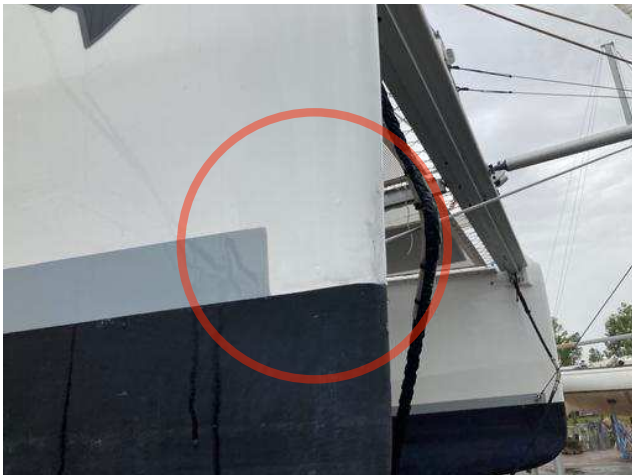
Different waterline  
colors near the bow area

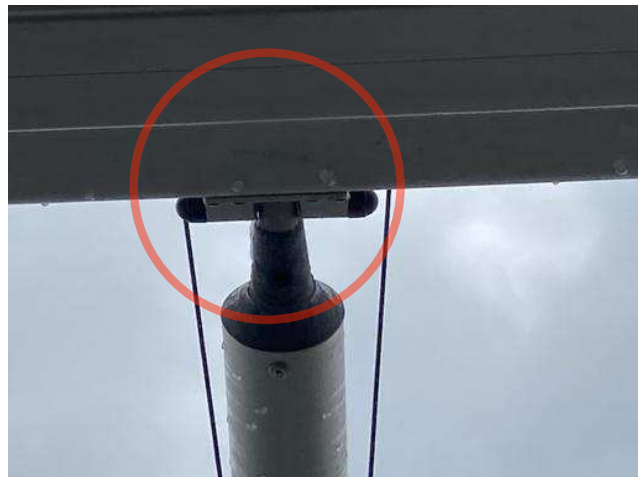
#24 Inspection date 09.06.2022

The boom seems to be bent or not properly installed in the centre line - it needs to be dismantled and checked

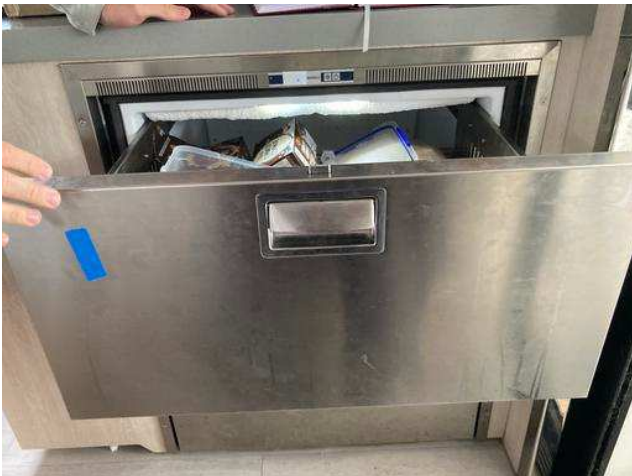
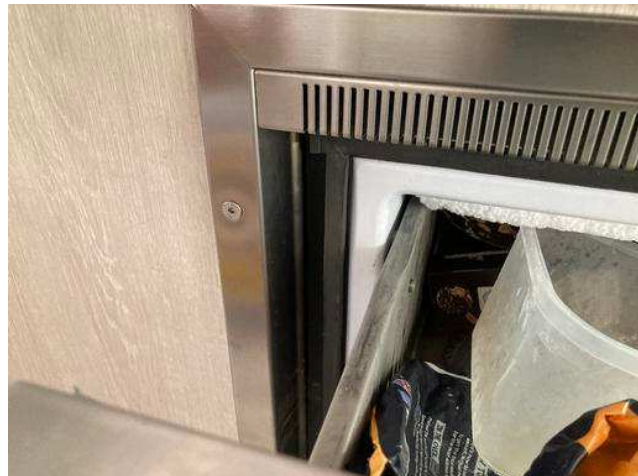
The fridge VITRIFRIGO located in the Stb salon does not close well. During navigation the drawer moves

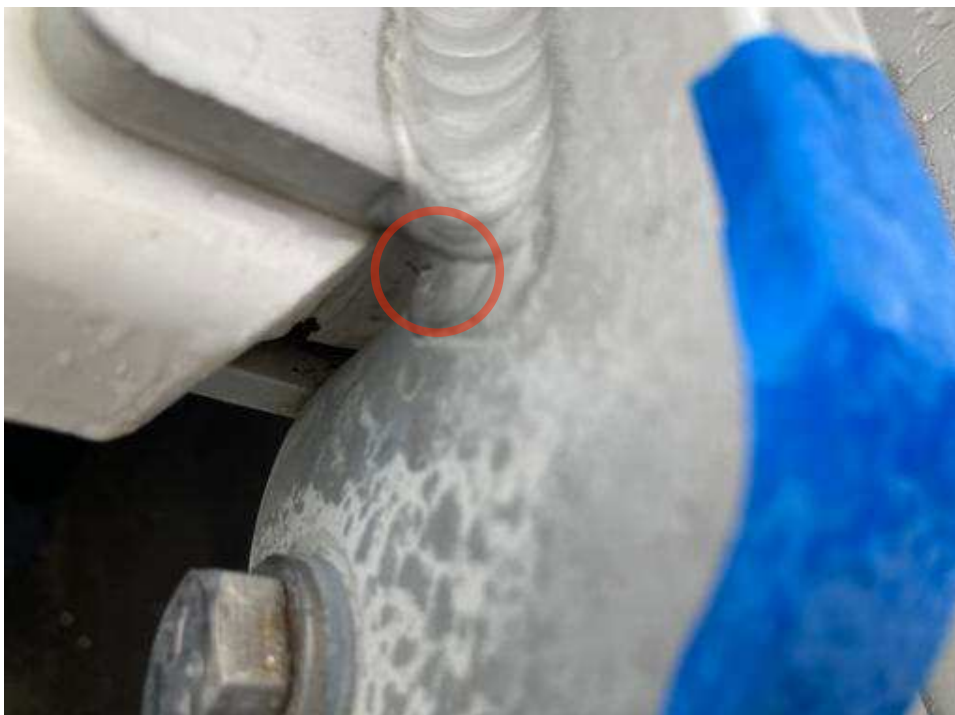
Cracks in code zero cross beam support welds . Will need to be removed and replaced for safety reasons

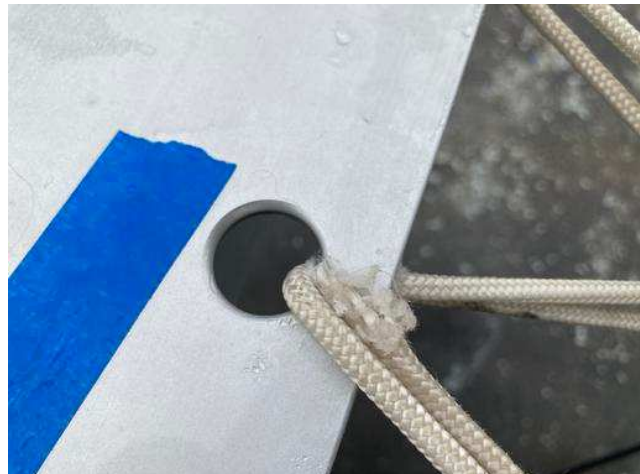
Not all the holes in the beam are properly finished and the webbing gets cut quickly. It needs to be replaced and the holes appropriately smoothed

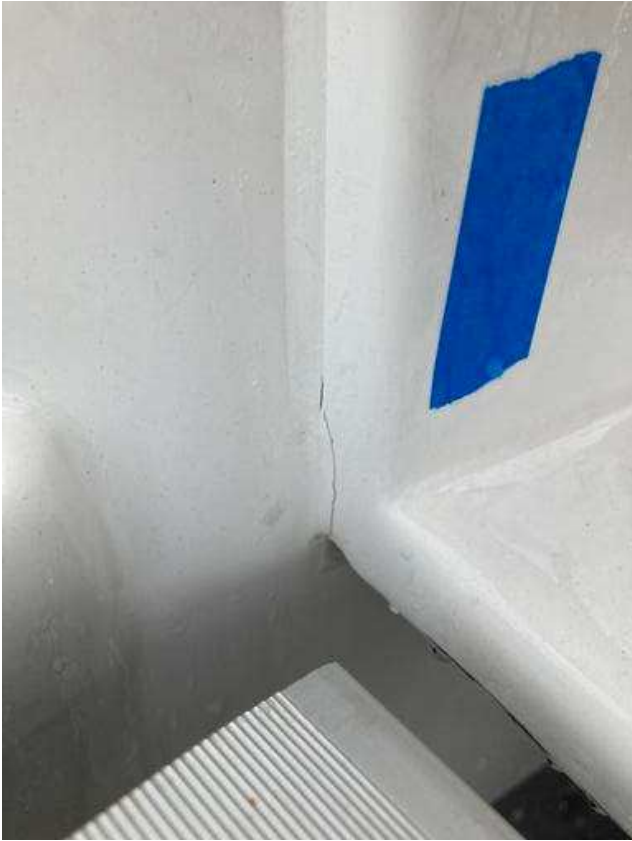
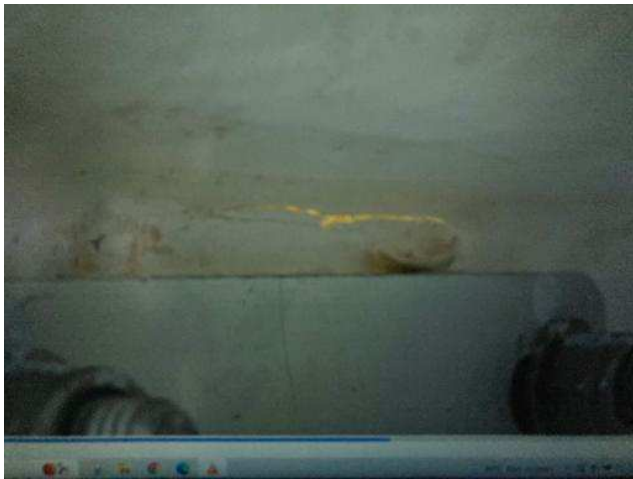
### #30 Inspection date 09.06.2022

Vertical cracks on both sides of the transverse beam support, these have already been repaired once and the cause of their reappearance must be investigated. It could be an extensive repair work with the need to review the lamination plan of these areas and bolts leaking on starboard side

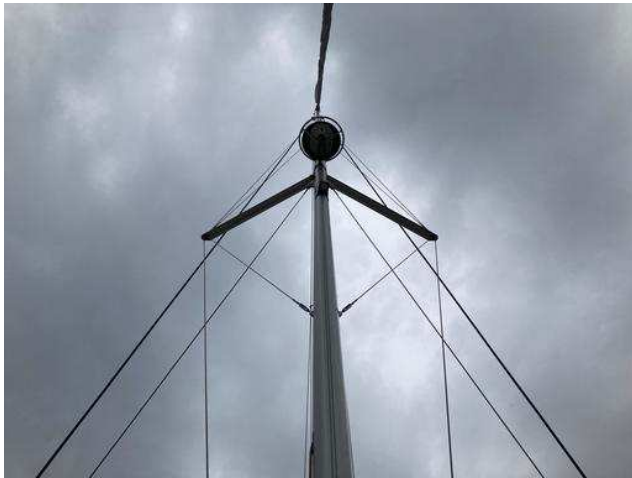
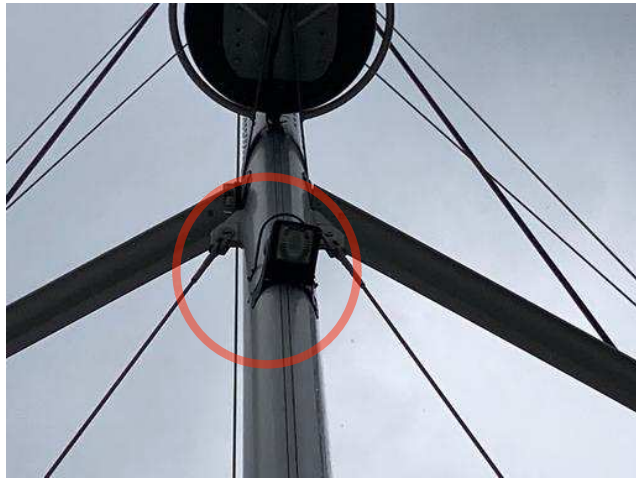
The deck light it is bent

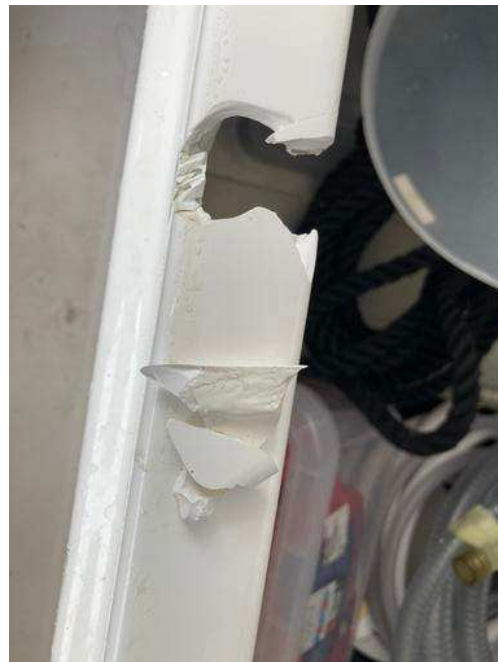
Hinge system of the technical locker is broken - Gelcoat around the hinge is broken - a review of the lamination structure is needed

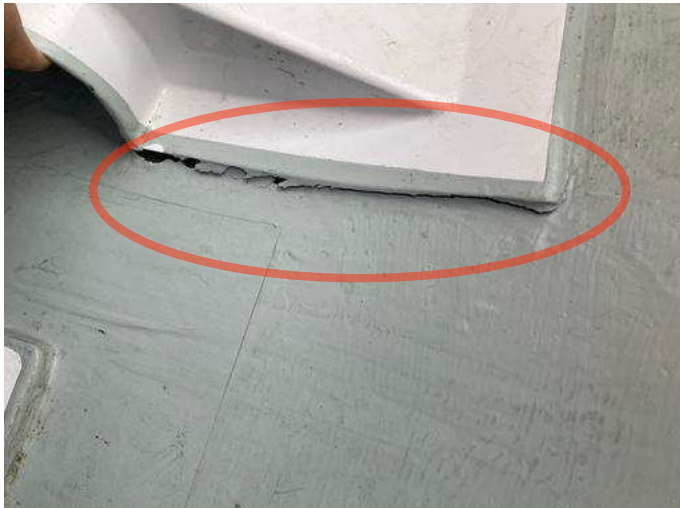
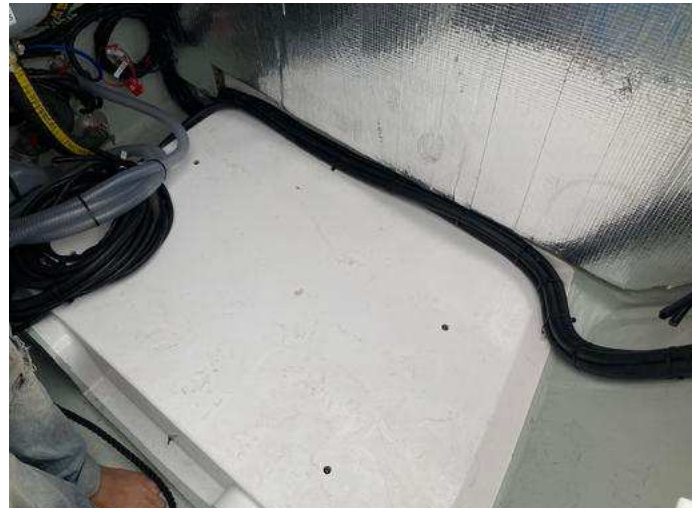
The GRP base (Generator position) is detached from the hull - New lamination is required in order to maintain the future Gen weight and loads

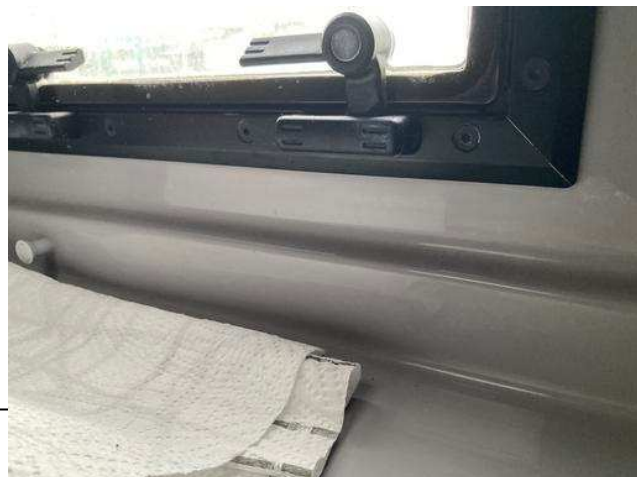
The portholes on the starboard side show water infiltration during navigation ; inadequacy of these aspects affects the integrity of the hull and therefore the safety of the vessel ISO 11812

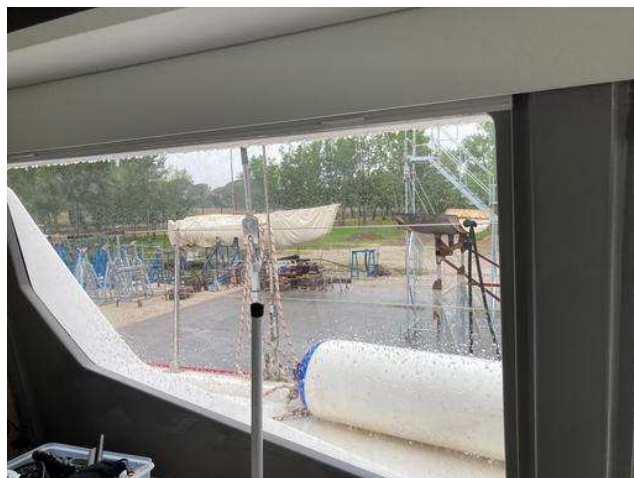
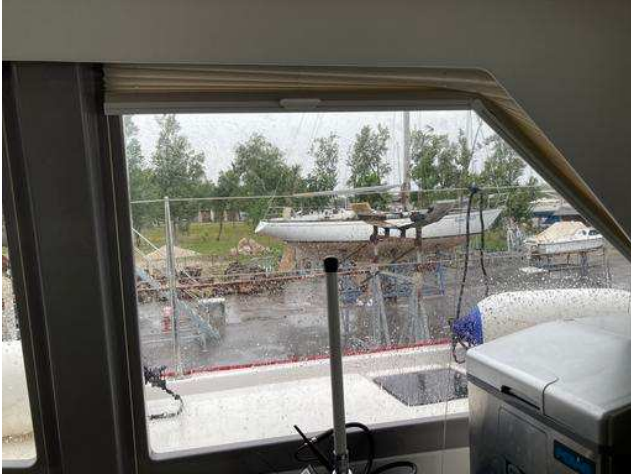
The glass of the deckhouse windows on the port side shows a high level of water infiltration, the inadequacy of these aspects affects the integrity of the hull and therefore the safety of the vessel ISO 11812

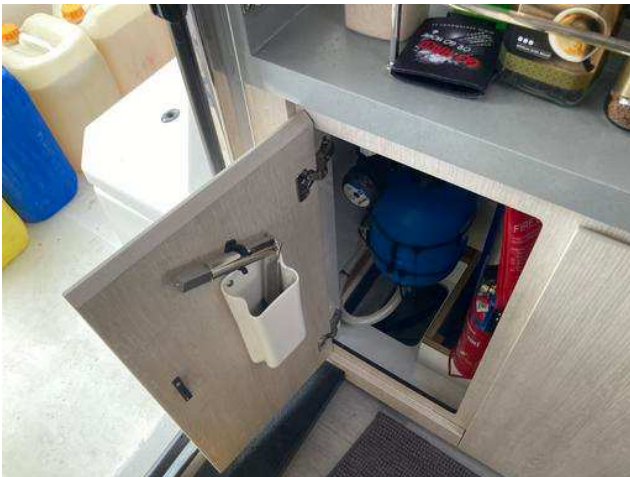
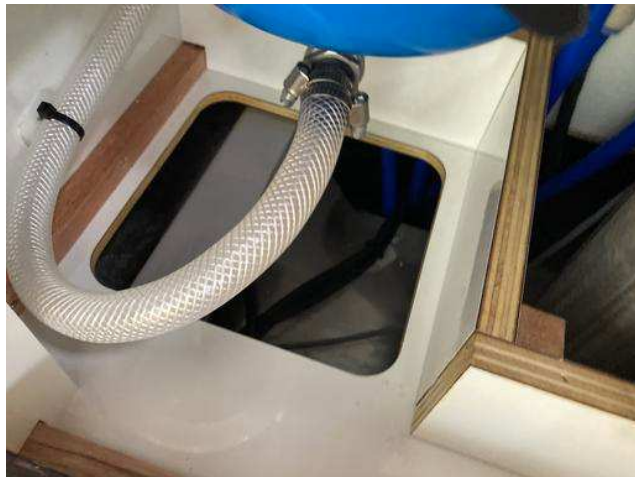
The wood cover inside this locker was never installed by the shipyard

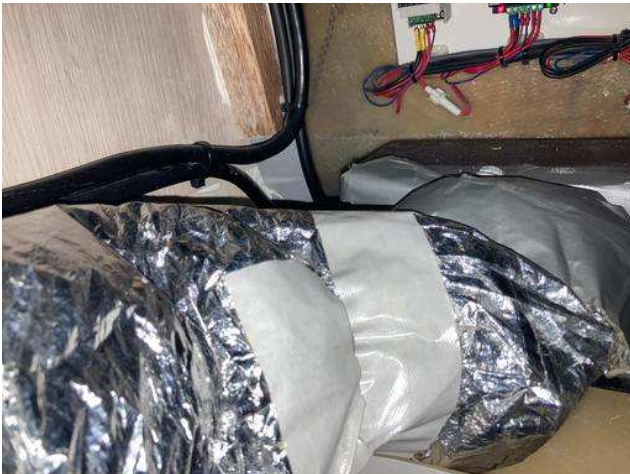
The air conduct (A/C) located inside the electronic area has been broken by someone who did the service in the shipyard

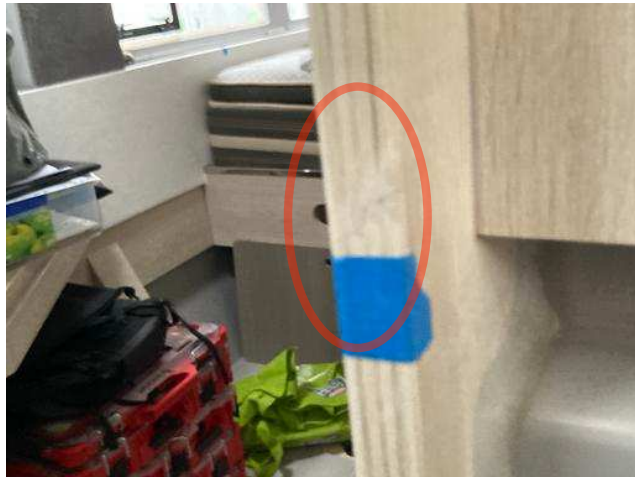
**Description**  
The ply wood  
is damaged

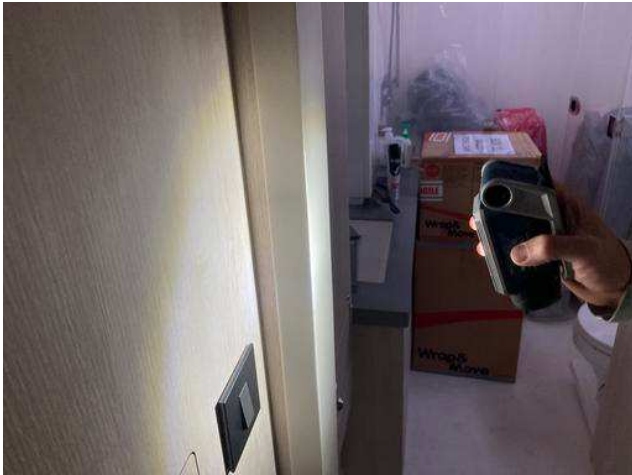
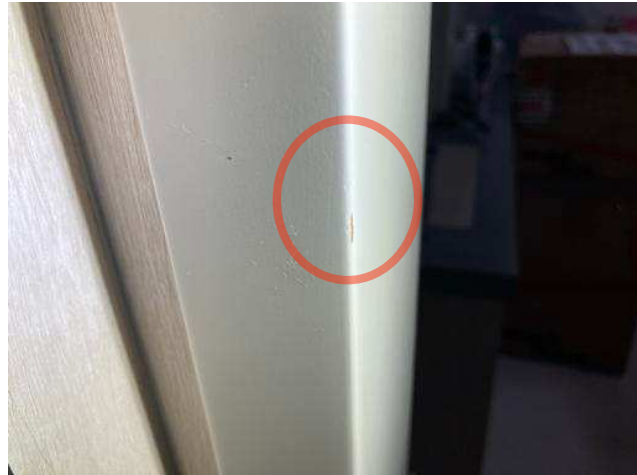
**Description**  
The internal paint finishing works were not fully completed

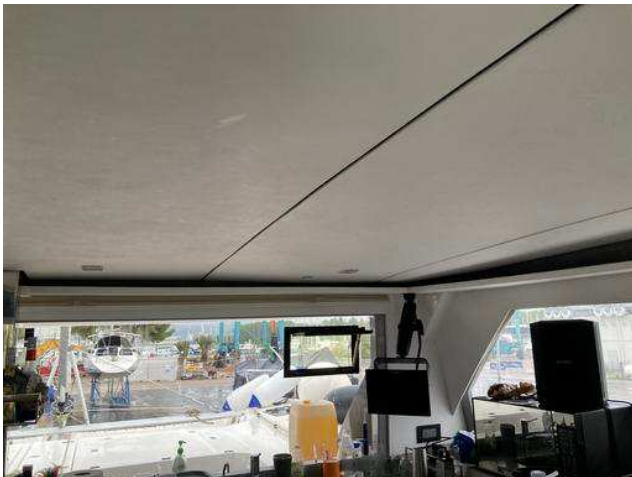
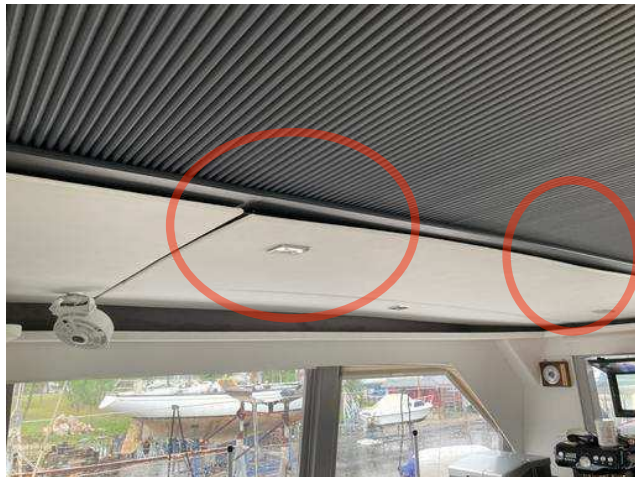
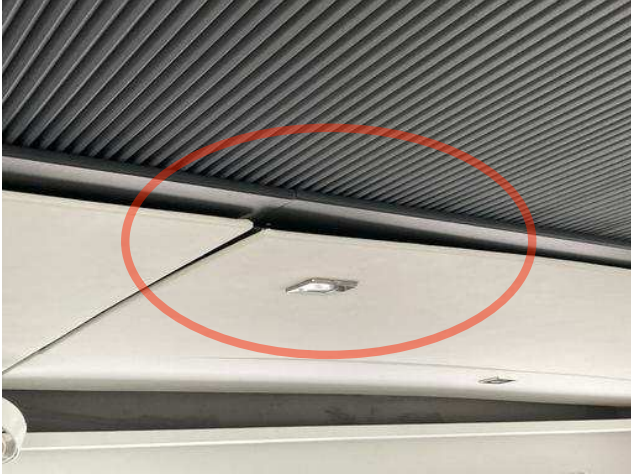
The ceiling panels in the salon have no hold on the frame underneath and have a tendency to fall. Ceiling panel fastening systems need to be reviewed.

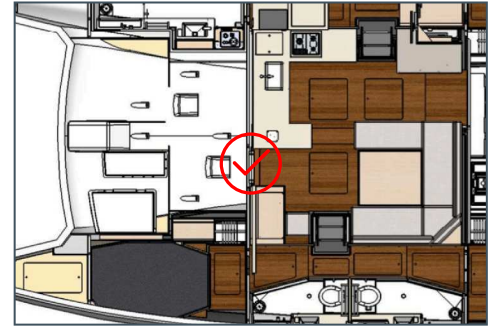
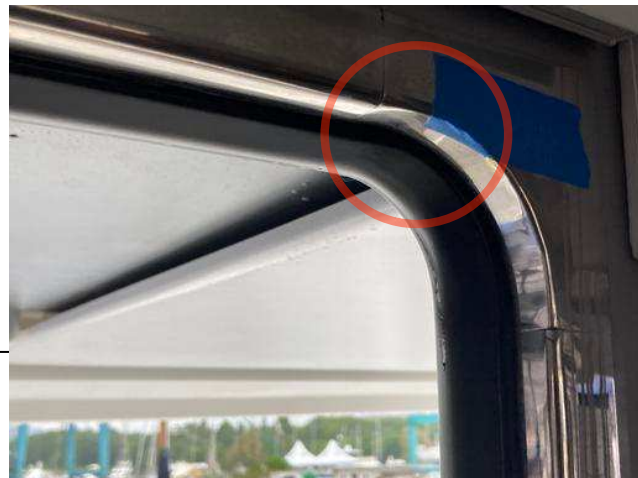
The right upper part of the frame shows oxidation formations due to water infiltration from outside. In navigation, the frame moves. The inadequacy of these aspects affects the integrity of the hull and superstructure and thus the safety of the boat ISO 11812

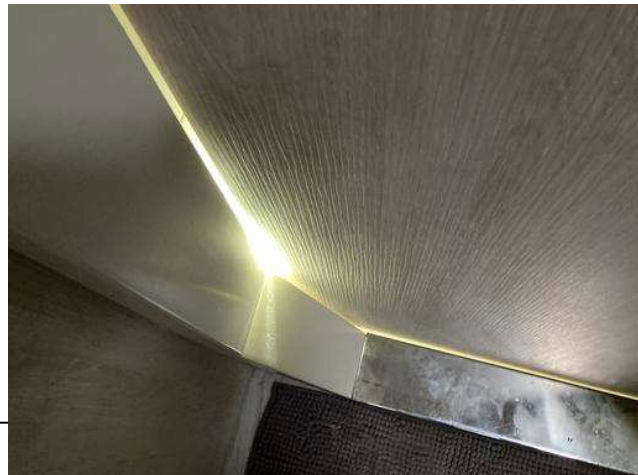
The sliding door in the bathroom is misaligned in relation to the stiffener, damaging the door covering

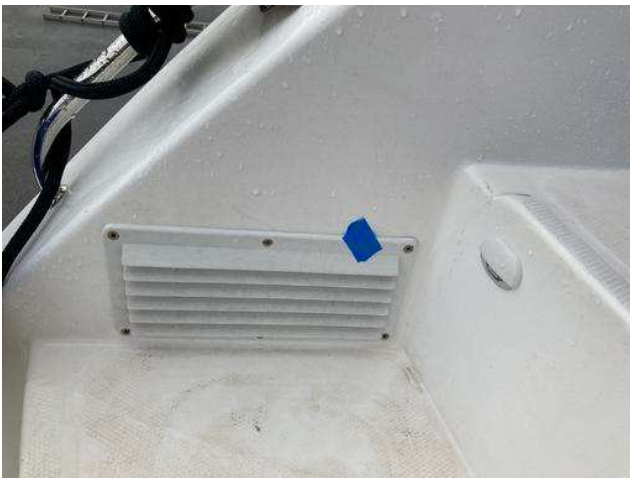
**Description**  
The air vent is broken

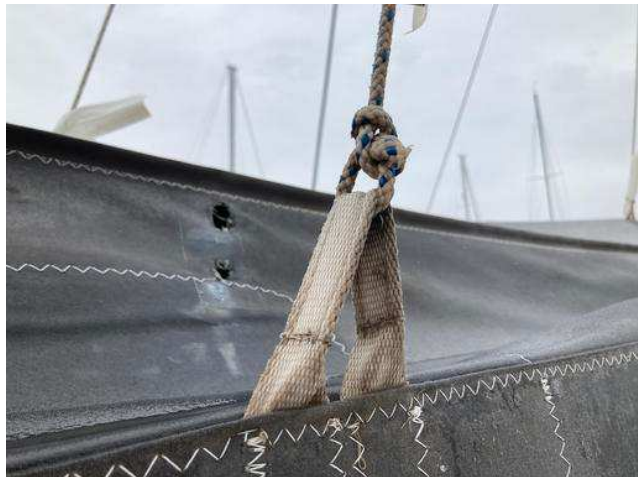
Mainsail cover is damaged due to incorrect installation of the lady bug

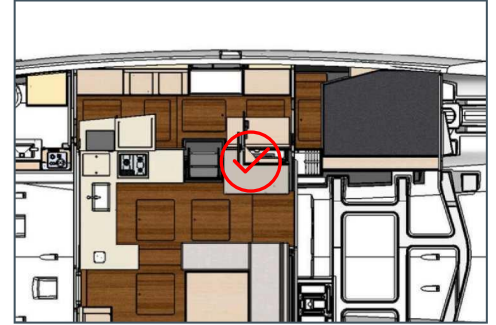
The various problems encountered in navigation with Raymarine instruments were verified by Raymarine Gibraltar. Remaining warranties will be followed up by Raymarine Italy.
